EXECUTIVE SUMMARY

Voltage Distortion & Power Quality Study for General Hospital Somewhere Valley, AK

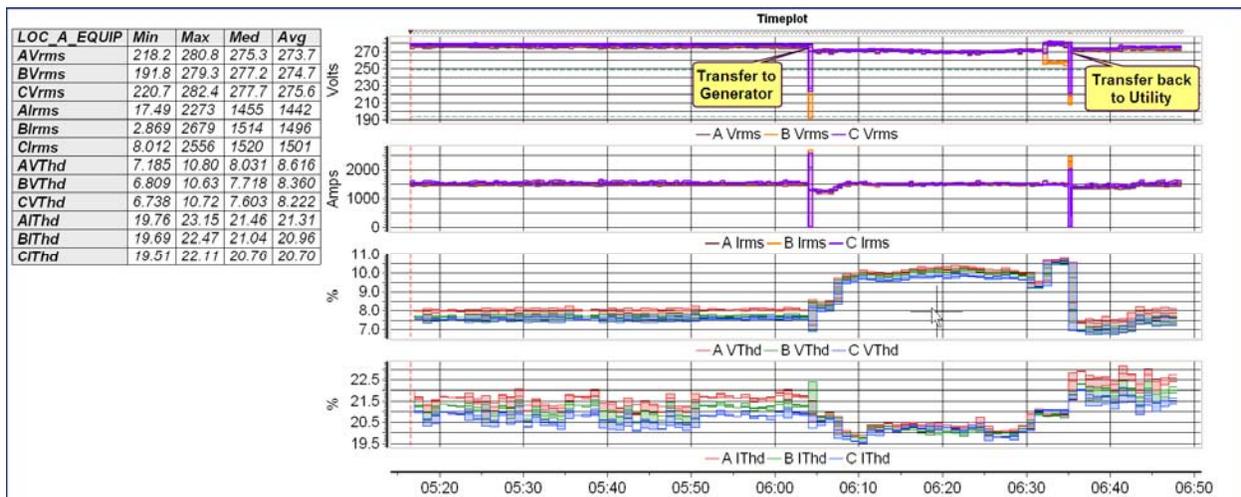
Figure 2 (below) shows the voltage, current and distortion plots for monitoring Location #3, ATS #2 which is the dominant source of the voltage distortion for the electrical distribution system

Figure 2 – Vthd and Ithd time plots of ATS (Monitor #3).

Under normal, utility operation the Vthd is in the 7% to 8% range and increase to between 9% and 10% when operating on the generator supply. This increase in Vthd is the result of the higher (about 3%) source impedance presented by the generators to the distribution system. Industry practices attempt to operate facilities in the 3% to 5% Vthd range for Utility operation and expect an increase when switching to the emergency generator supply.

RECOMMENDATION: The $V_{thd_{fnd}}$ associated with the 1500A/phase ATS #2 (Monitor #3) should be reduced to less than 4% under normal utility power source operation. This can be accomplished through:

1. Change out of existing 3% impedance line reactors for 5% impedance reactors, and
2. Installation of phase shifting, zigzag transformers on some of the drives to cancel out 5th and 7th harmonic currents. The advantage of the phase shifting is that it is a passive harmonic filter and does not present the problem of cross-talk or interaction between other system distribution components that conventional harmonic filter might.

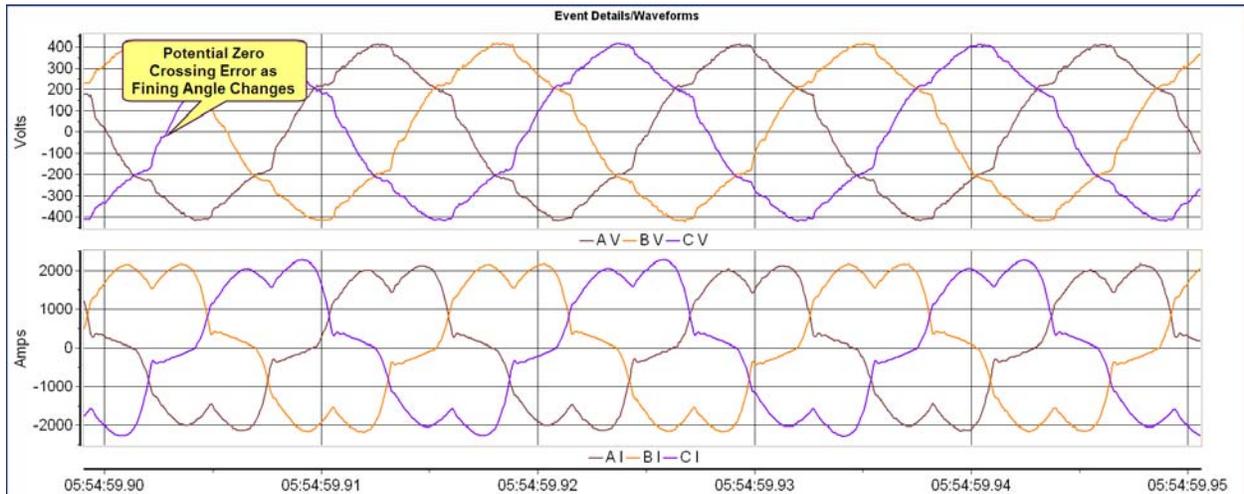
Figure 3 (below) shows the voltage and current waveforms during normal utility source operation just prior to the generator test conducted on October 15th. The current waveforms are typical of 6-pulse rectified loads with line-reactors installed.

The loading on the ATS #2 (Monitor #3) was approximately 1500A/phase at 480Vac phase-to-phase and consists of the larger environmental loads, HVAC, for the facility. Analysis of the voltage and current waveforms indicates that the distortion is dominantly the balanced doublets 5th - 7th and 11th - 13th harmonics from the 6-pulse drives associated with the motor loads.

Figure 3 – Monitor #3 (ATS #2), utility source, voltage (phase-to-neutral) and current waveforms showing typical 6-pulse current waveforms.

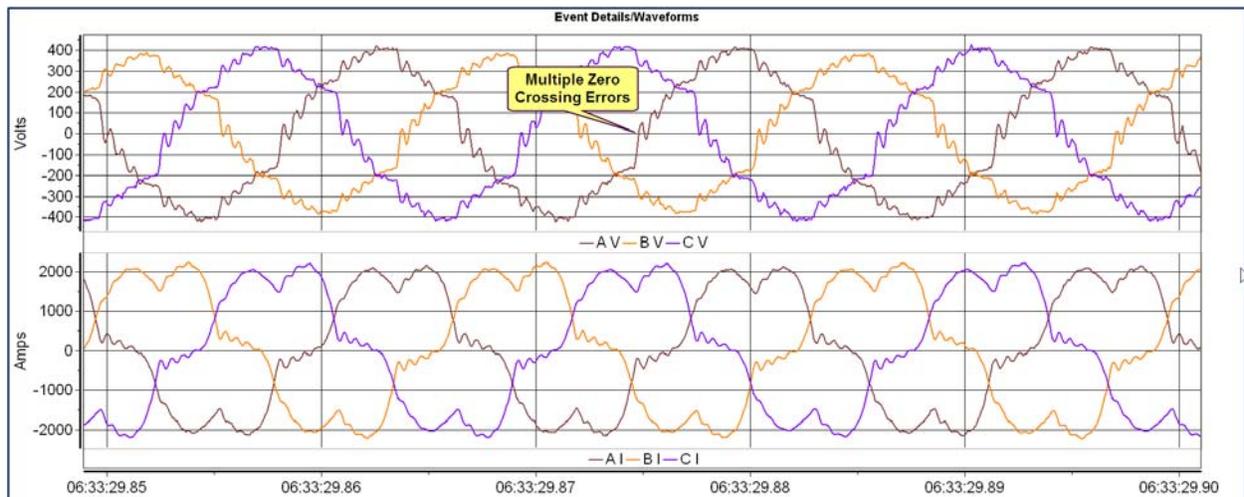
Figure 4 (below) shows the voltage (line-to-neutral) and current waveforms for the ATS #2 (Monitor #3) operating on the generator supply. Note the increase in voltage distortion and the prominent multiple zero-crossings which typically cause drives to “trip-off” as they can not synchronize properly. [Note: It was reported that a number of drives had “trip-off” during the early morning testing on October 15th.]

Figure 4 – Monitor #3 (ATS #2), generator source, voltage (phase-to-neutral) and current waveforms showing distortion and multiple zero-crossing errors.

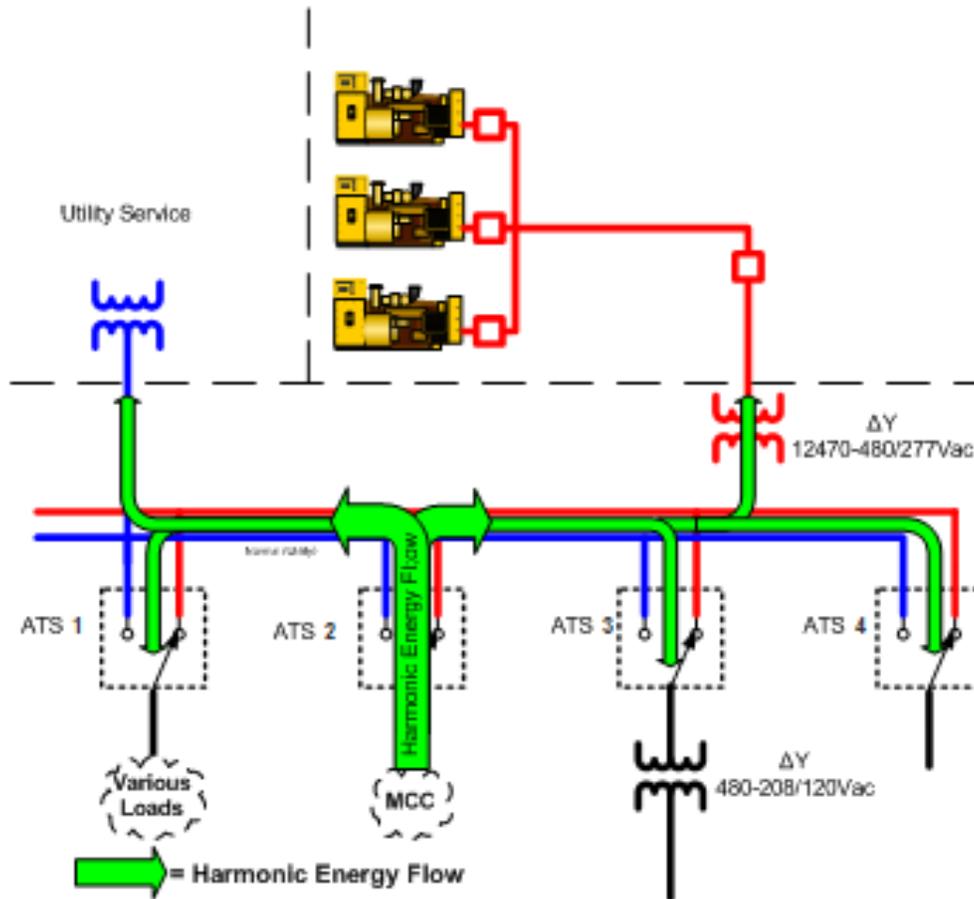
In summary the primary driver of the distortion on the electrical distribution are the large environmental loads and their associated 6-pulse drives. Unacceptable levels of distortion are present regardless of the power source—utility or emergency generator. Figure 5 (below) graphically illustrates the problem and the flow of harmonic energy in the distribution system.

Figure 5 – Simplified single-line showing direction of harmonic energy flow [GREEN].

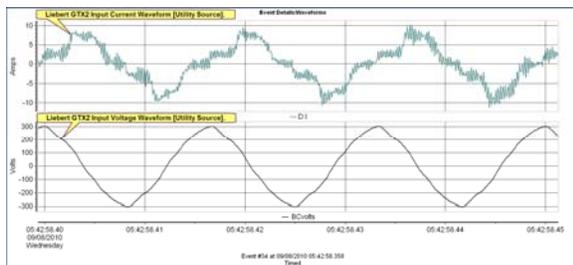
Figures 6 and 7 (below) are current and voltage waveforms for the UPS equipment when powered from utility source and generator source respectively. The UPS power supply is *power factor corrected* which means it tries to follow the voltage waveform. If the voltage is distorted then the corresponding current waveform will be distorted.

Figure 6 –UPS input voltage and current waveforms—utility source

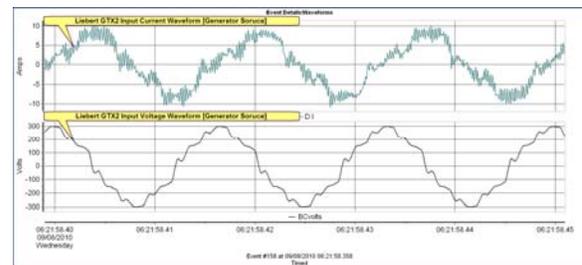
Figure 7 UPS input voltage and current waveforms—generator source

The active harmonic filter is also a voltage following device which means there are two devices in series trying to compensate for the distortion. The result is generally an unsatisfactory condition.

RECOMMENDATION: Install 5kVA transformers on the input power to the UPS equipment. This will buffer the power factor corrected supply from the source and result in improved performance. Do NOT install any type of active regulating device in series with this type of application.

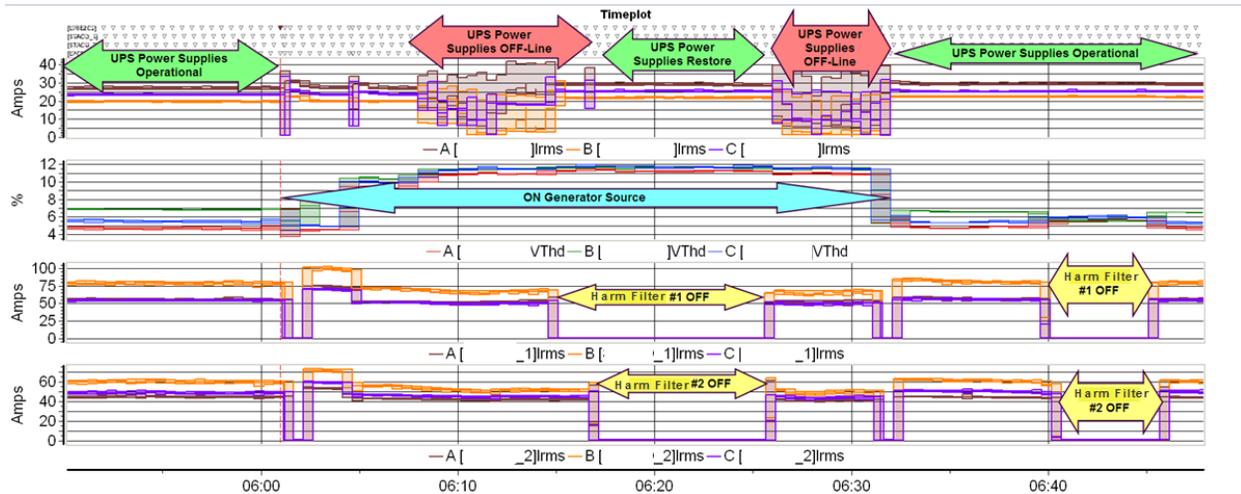
During the testing activities on October 15th several of the UPS's failed to come on-line when transferred to generator. As an experiment the active harmonic filters were turned off, Figure 8 (below), and the current hunting from the UPS equipment stopped and the UPS equipment came on-line and started charging the batteries. It appears from this experiment that the increase in voltage distortion when operating with the generators as the power source results in an unstable condition in which, at least some of the UPS's, can not accept the voltage signal. Disabling the active harmonic filter equipment allows the UPS equipment to return to normal operation.

Observations of the active harmonic filter equipment under normal operating conditions do not reveal any significant benefit from operation of the equipment in this application.

Figure 8 – Active harmonic filter current time plots versus UPS current plot documenting UPS power supply stability when active harmonic filters are OFF.

RECOMMENDATION: From the testing results the active harmonic filter equipment is not improving the operating environment for the UPS equipment and should be removed from this application. During emergency generator operation the equipment actually appears interfere with the reliable operation of the UPS equipment.
