EXECUTIVE SUMMARY

Voltage Distortion & Power Quality Study for General Hospital Somewhere Valley, AK

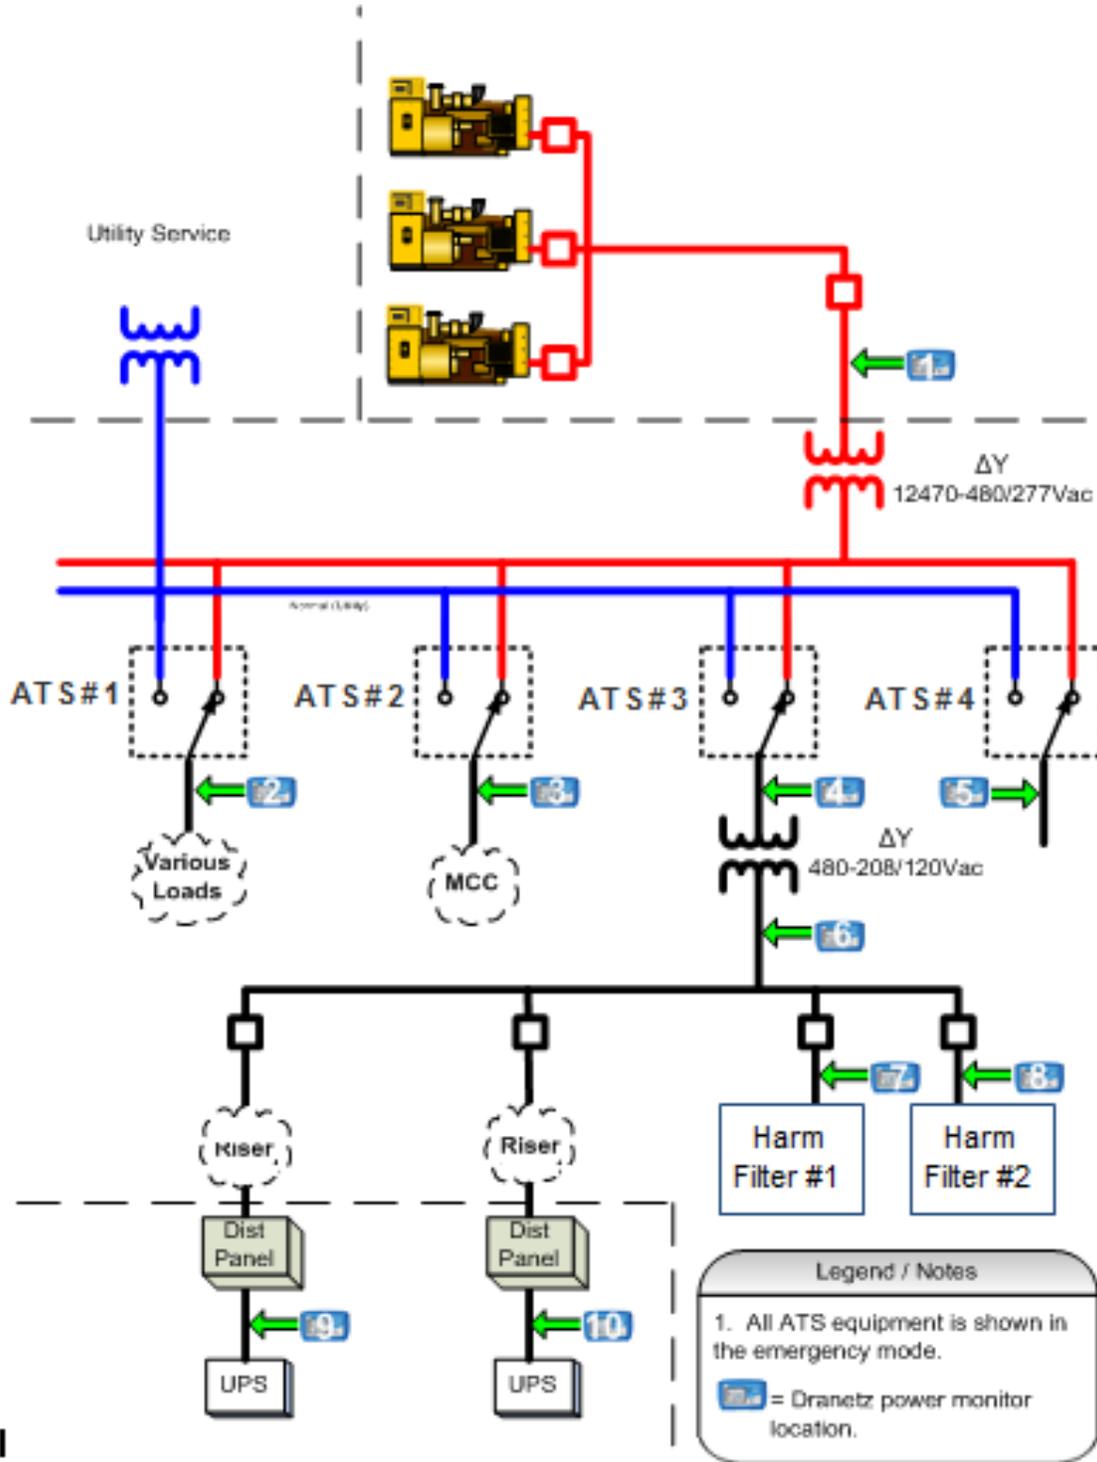
Figure 1 – Simplified single-line of Building A's electrical distribution system.

Figure 1 is a simplified diagram of the normal and emergency electrical distribution associated with the facility. A total of ten (10) Dranetz power monitors were used and set to record both periodic (timed) readings as well as transient conditions. More detailed information on testing configuration is available in the full study report.

The load side of the ATS #3 (see Figure 1) connects to a 480-208/120Vac step-down distribution transformer that distributes 208/120Vac power to a series of equipment rooms on each floor. Part of the load in each of the rooms is a UPS, 4.2kW (5.2kVA). The UPS is connected as a 208Vac single-phase device and has input power factor correction.
